LOCTITE**Adhesives for more
reliable assemblies****APPLICATION CASE HISTORY****No. 262**

Loctite® 587 Blue High Performance RTV Silicone Seals Lead Balance Weights On Aircraft Wheels

Does Not Corrode Magnesium; Provides Good Visibility

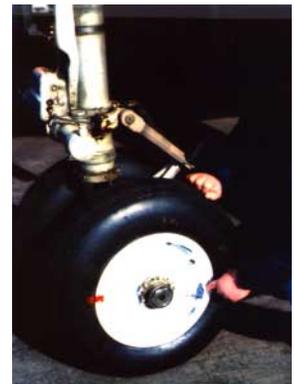
Corrosion caused by acetoxy-based silicone to the magnesium nose wheels of airplanes, forced an Alaskan-based air carrier to put 16 wheels out of service, costing the company \$90,480 in 1990-96.

Loctite® 587 Blue High Performance Silicone does not cause corrosion, protects against de-icing material, and allows for a quick visual check for missing balance weights.

Loctite® 587 Blue High Performance RTV Silicone is an instant gasket maker and sealant that offers excellent adhesion to oily surfaces. It withstands temperatures from -75° to +500° F (-59° to + 260° C), is resistant to most chemicals and solvents, and fills gaps to 0.25". Loctite 587 is manually applied to the nose wheel of the aircraft around the perimeter of the lead weight, and then over the top of the weight.

The non-corrosive properties of Loctite 587 do not cause corrosion on the magnesium wheel assemblies, while its blue color allows maintenance personnel to do a quick visual check for missing weights. Loctite 587 Blue has been so successful in sealing the lead balancing weights on the magnesium nose wheels, the air carrier has instituted its use on all the aircraft wheels in its fleet.
